BR 3-150 N&S Photos

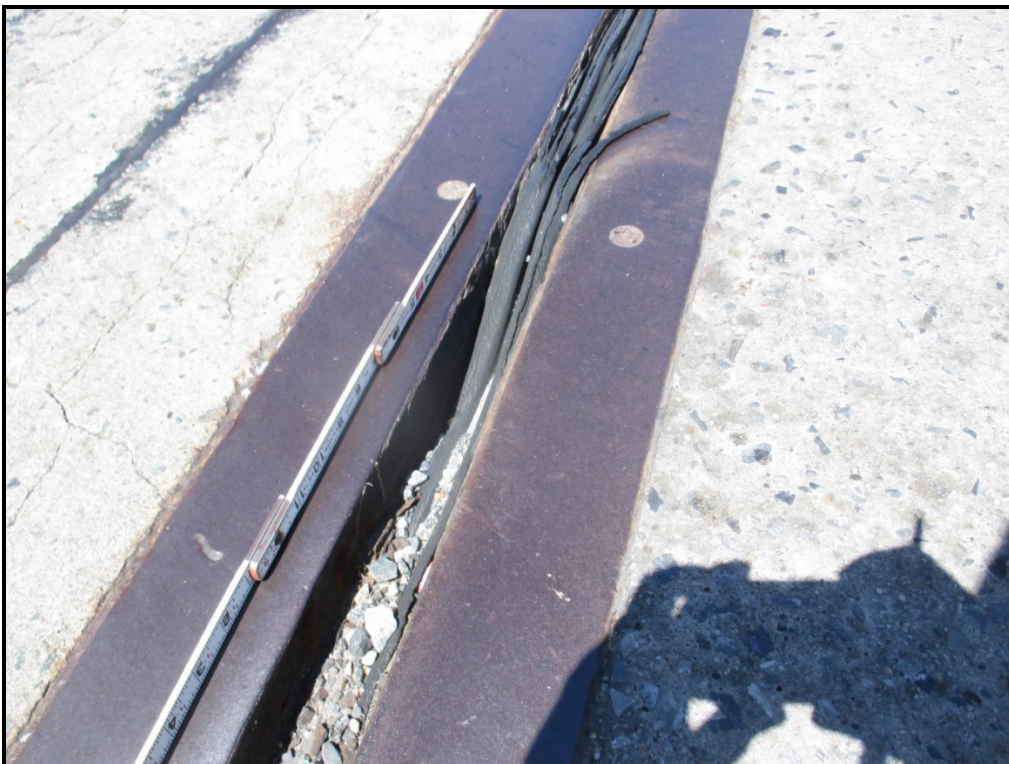
4. Sagging Compression Seal

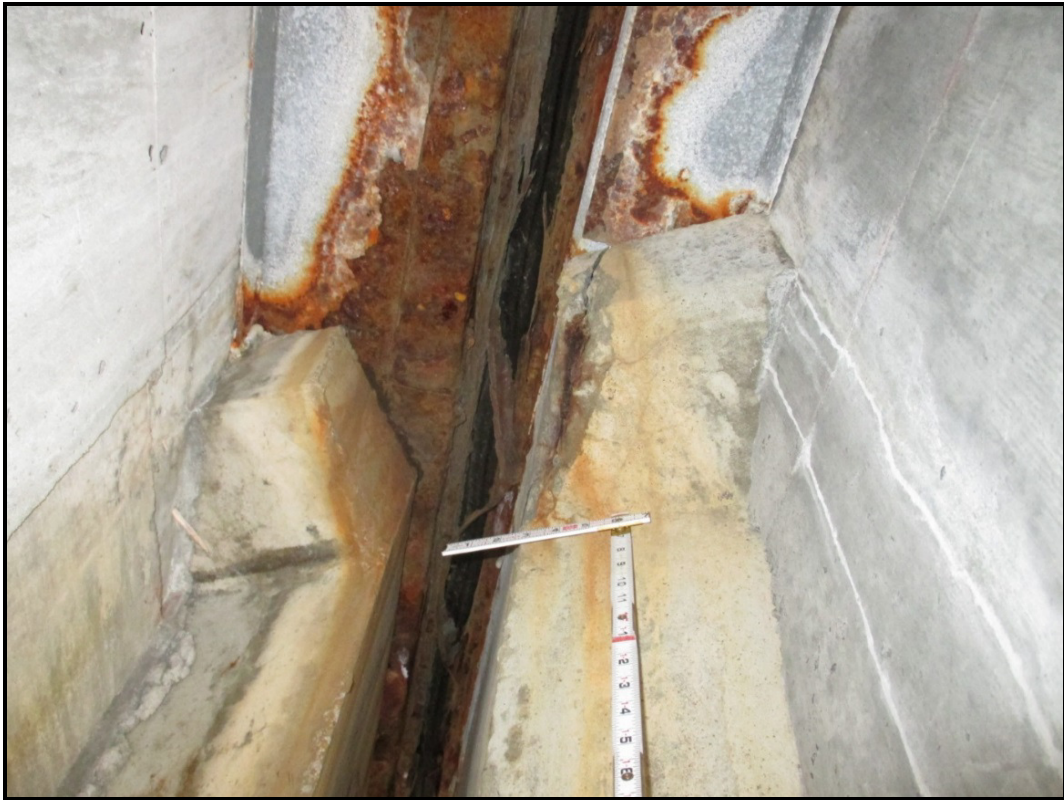
5. Leaking Joint

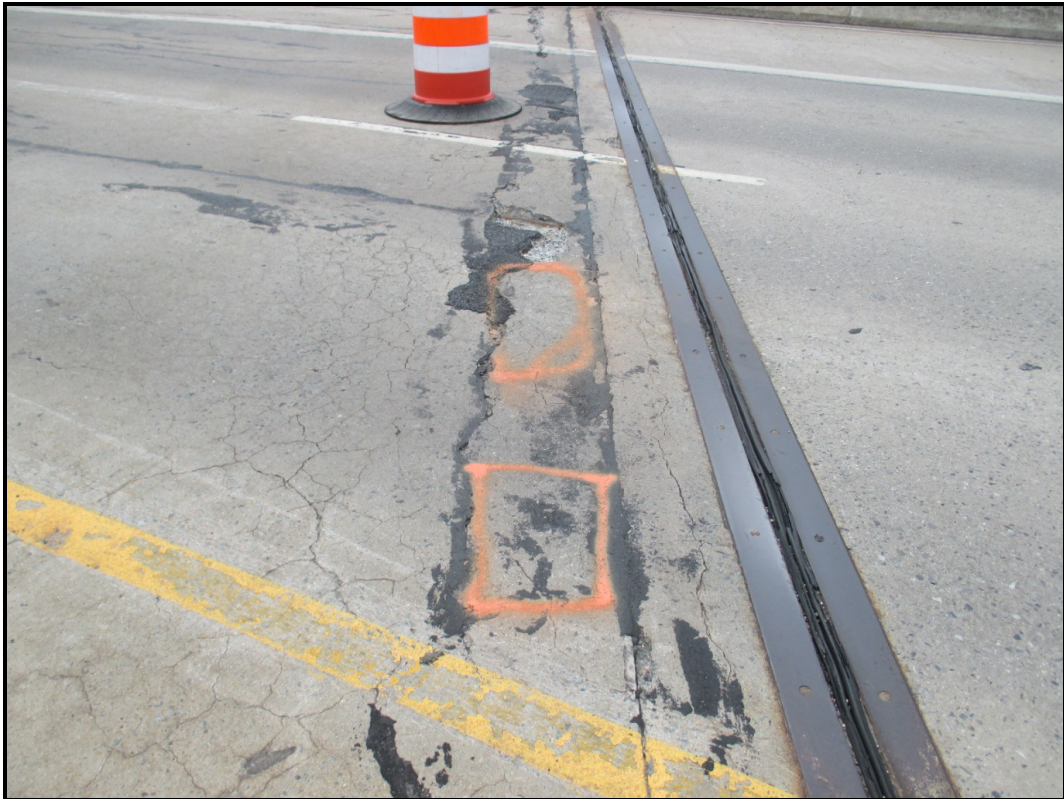
6. Approach Slab Spalls and Delaminations

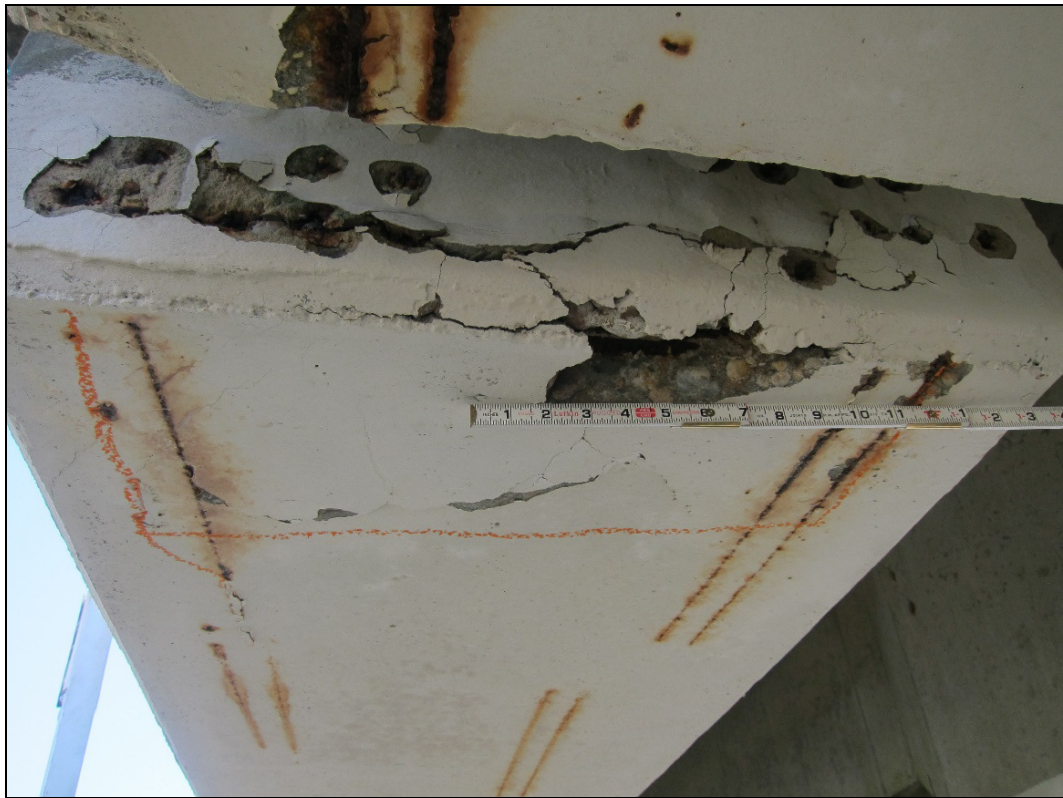
7. Beam Spalls

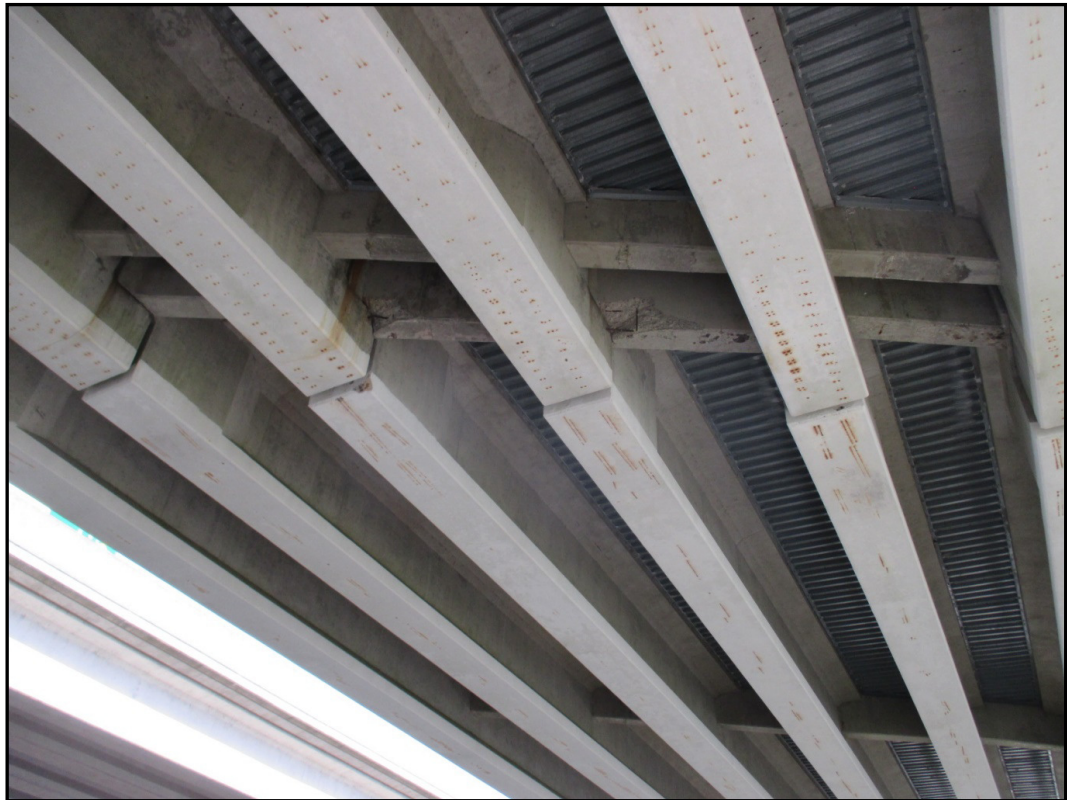
8. Drop-In Girder Misaligned

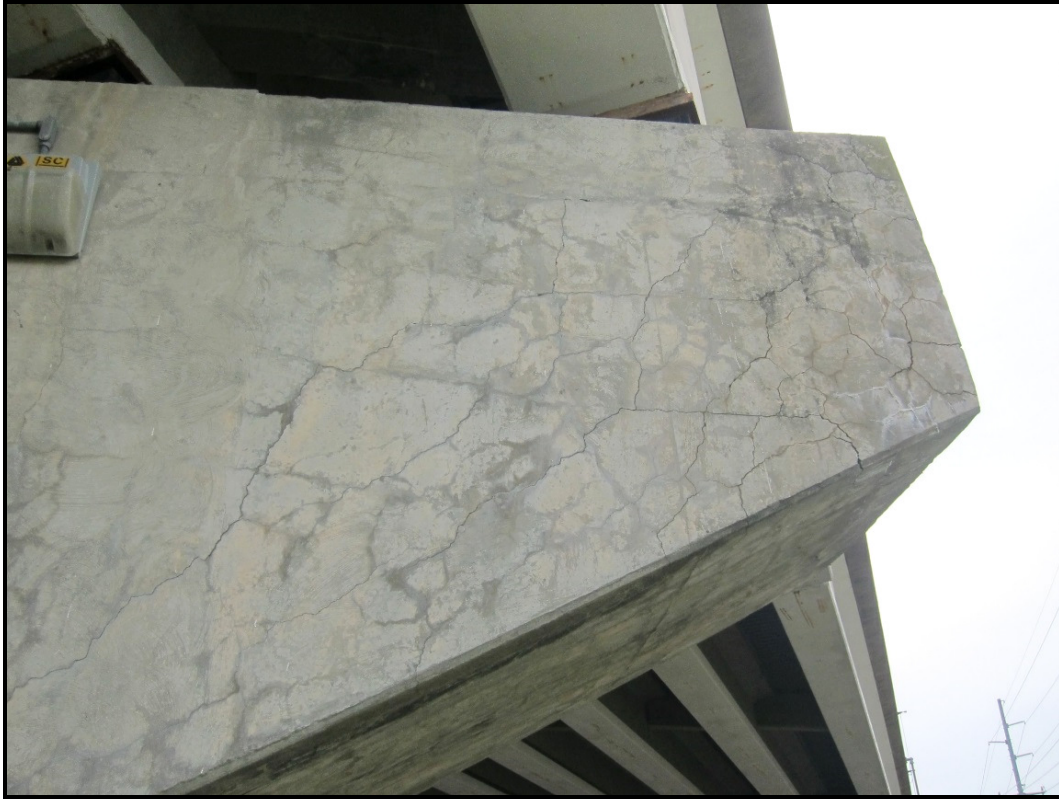
9. Pier Cracks

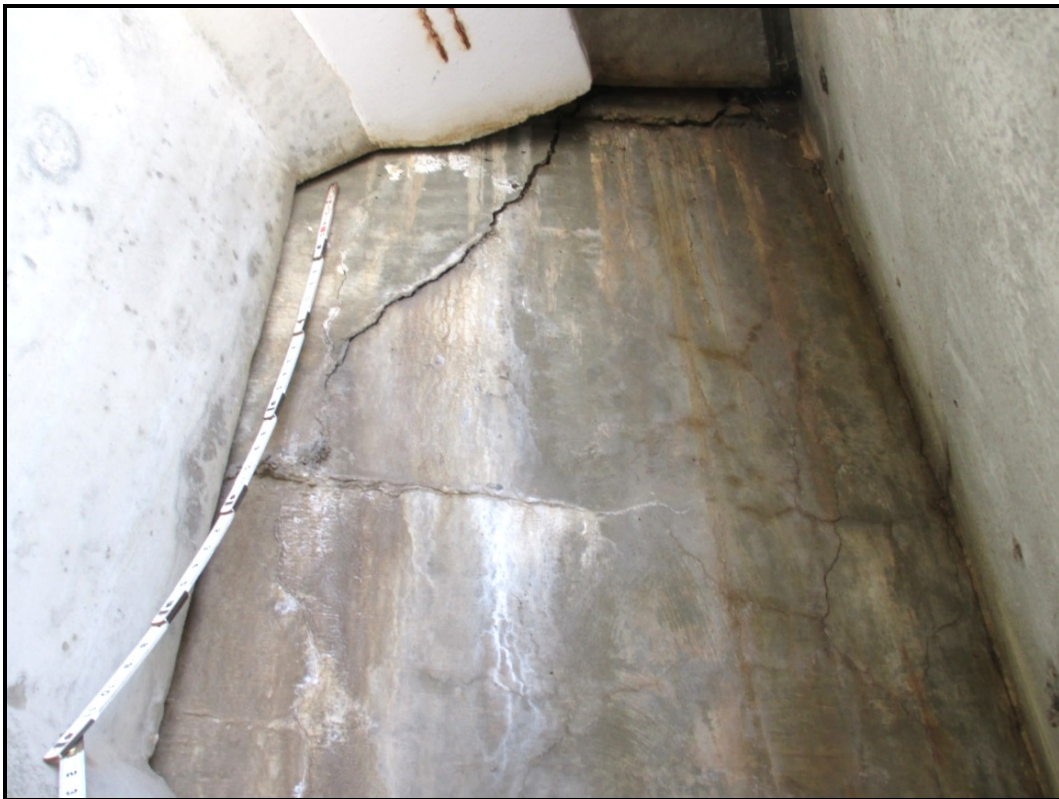
10. Abutment Cracks with Efflorescence

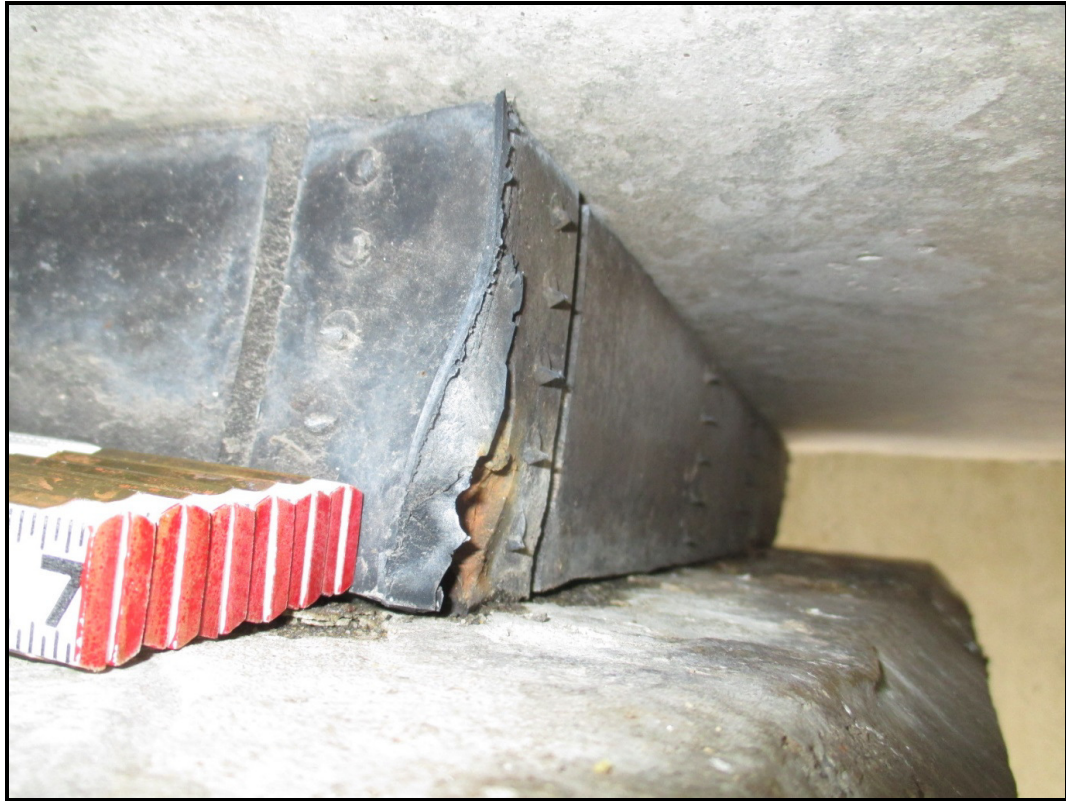
11. Elastomeric Bearing Splitting

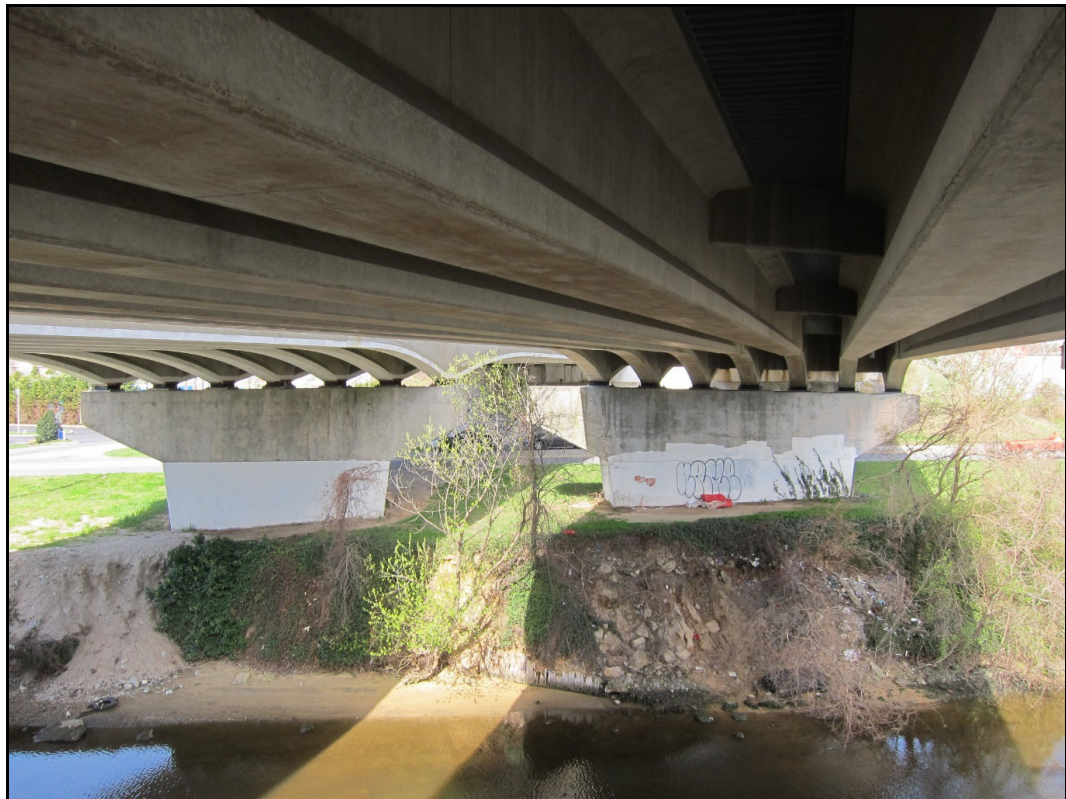
12. Channel Slope Erosion
